**ENGINEERING GEOLOGICAL STUDY OF
ROCK SLOPE STABILITY ALONG THE
DOKAN – KHALAKAN ROAD,
KURDISTAN REGION, NE-IRAQ**

**A THESIS SUBMITTED TO THE COLLEGE OF SCIENCE, UNIVERSITY
OF SULAIMANI, IN PARTIAL FULFILMENT OF THE
REQUIREMENTS FOR THE DEGREE OF
MASTER OF SCIENCE
IN GEOLOGY**

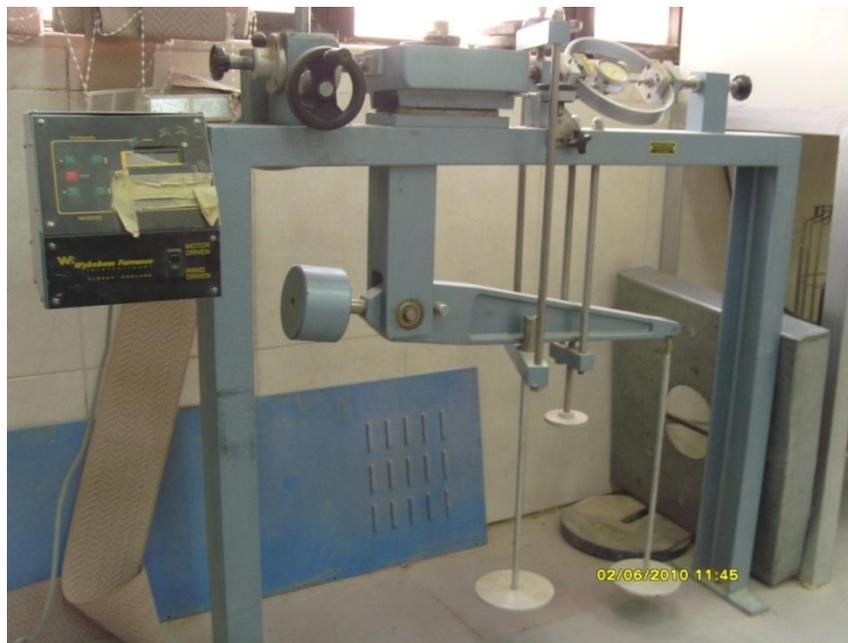
Figure (3-1) Shear box test apparatus

The main requirement for occurrence of plane or wedge sliding along failure surfaces is that, the dip angle of failure plane (θ) must be equal or greater than the friction angle (ϕ). due to the presence of clay seams between the failure surface, so the direct shear tests for undrained condition were carried out to determine the friction angle of clay. The shear box apparatus is shown in Fig (3-1). For this test, disturbed soil samples between rock layers were used (3 samples per each station), fig(3-2A and B). In this test both the friction angle (ϕ) and the cohesion of soil (c) are determined table (3-3).

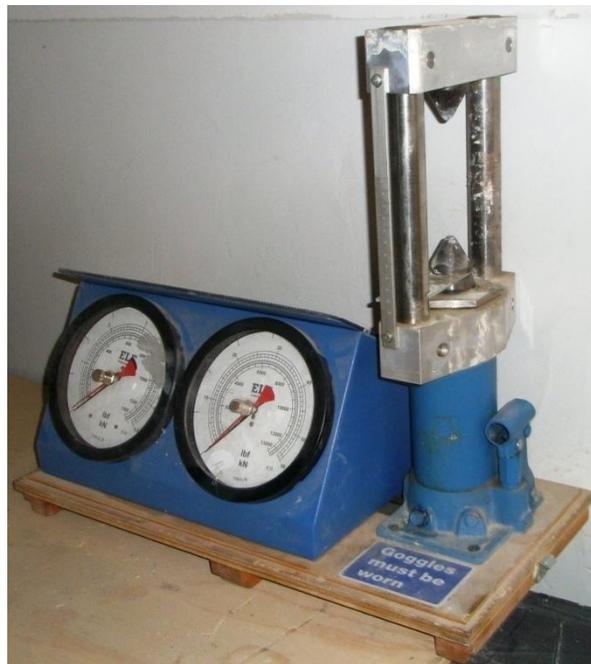
Figure (3-3) Point load test apparatus (ELE)model

The point load test (PLT) is an accepted rock mechanics testing procedure used for the calculation of rock strength index figure(3-3) .This index can be used to estimate other rock strength parameters; The PLT is an efficient method to determine intact rock strength properties from drill core samples. It has become an accepted test in geotechnical evaluations (Rusnak and Mark, 2000) .The Point Load test (Broch and Franklin 1972) has been used since 1960 and has become the most popular of the simpler techniques. A core is loaded between two ‘points’ which are steel cones subtending an angle of 60° and terminating in a hemisphere of 5 mm radius Fig(3-3). The core is usually loaded across a diameter. The test specimen length should be at least 1.5 times the length of the diameter.

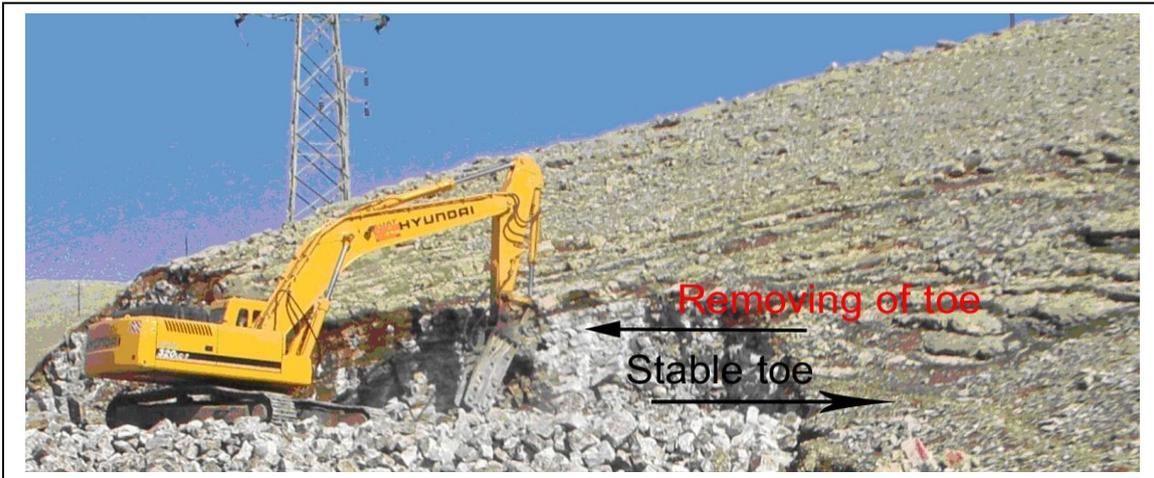
Plate (4.1): a) Shows the process of destabilization at station No.1 due to road widening and removal of the toe

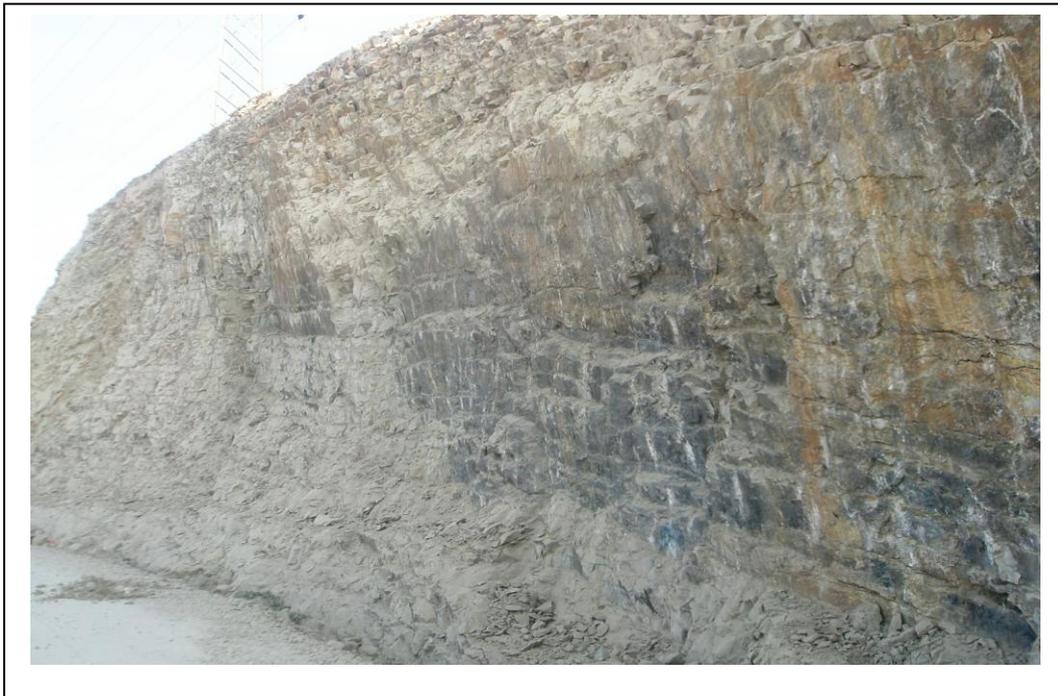
Plate (4-1): b) Unstable slope after cutting its toe at station No.1

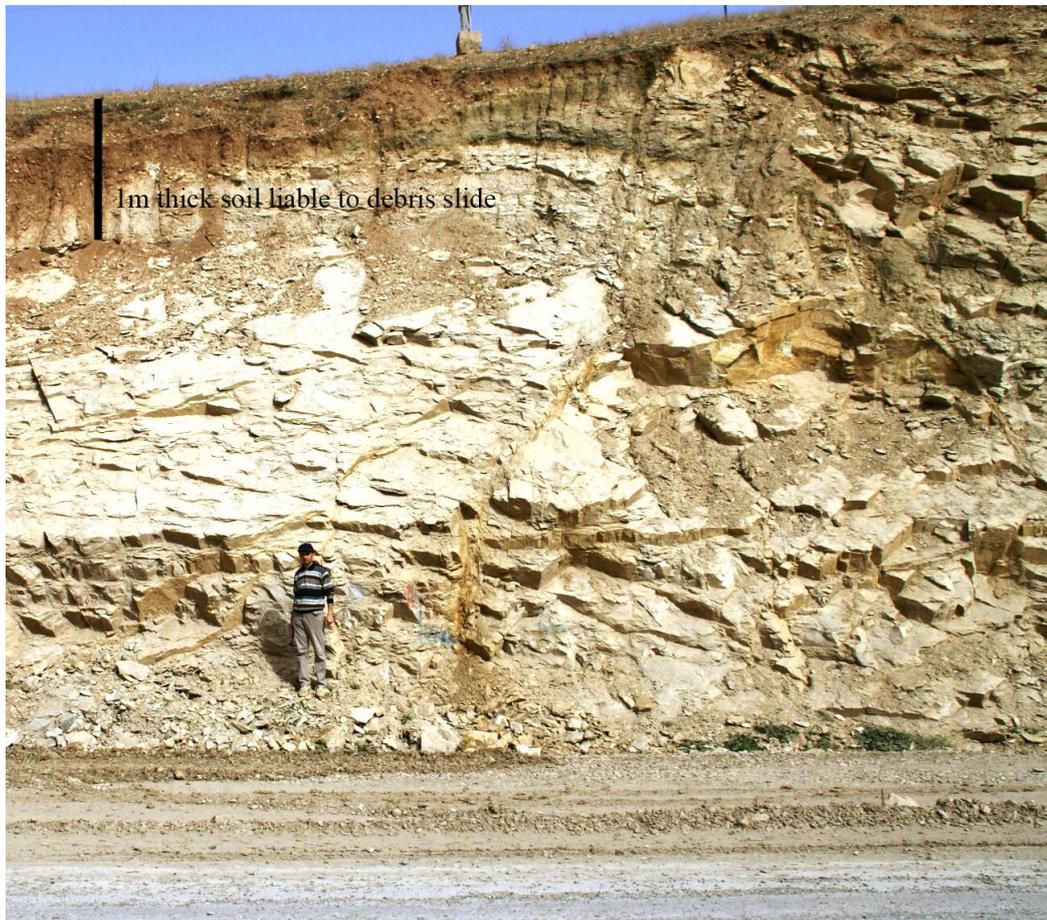
Plate (4-3): Frontal view of slope at station No.2

Mode of failure: the lower part of slope is daylighting slope because the angle of bedding plane is less than slope angle therefore sliding is likely to occur along bedding planes while joints in J1(hkO₁) and J2(hkO₂) act as back composite release surfaces(plate4-4 c). Rockfall has occurred and likely to occur more in the upper steep meters of the slope.

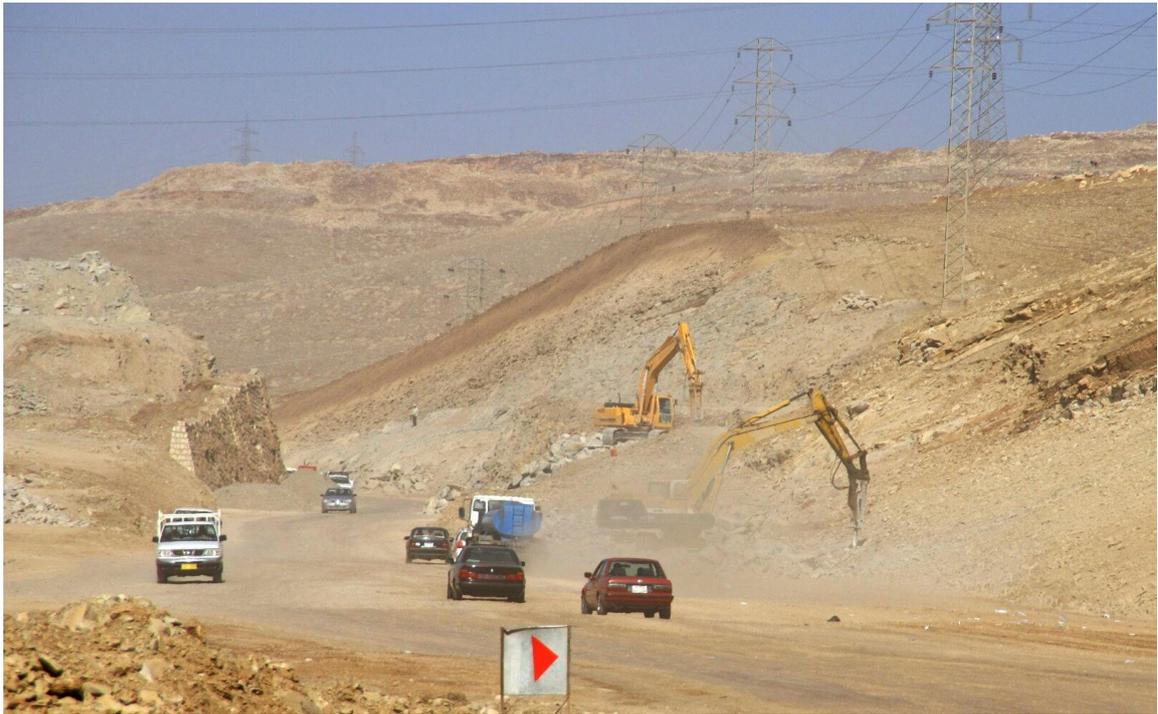
plate (4-7d): The processes of widening of the road between Dokan to Khalakan at station No.4

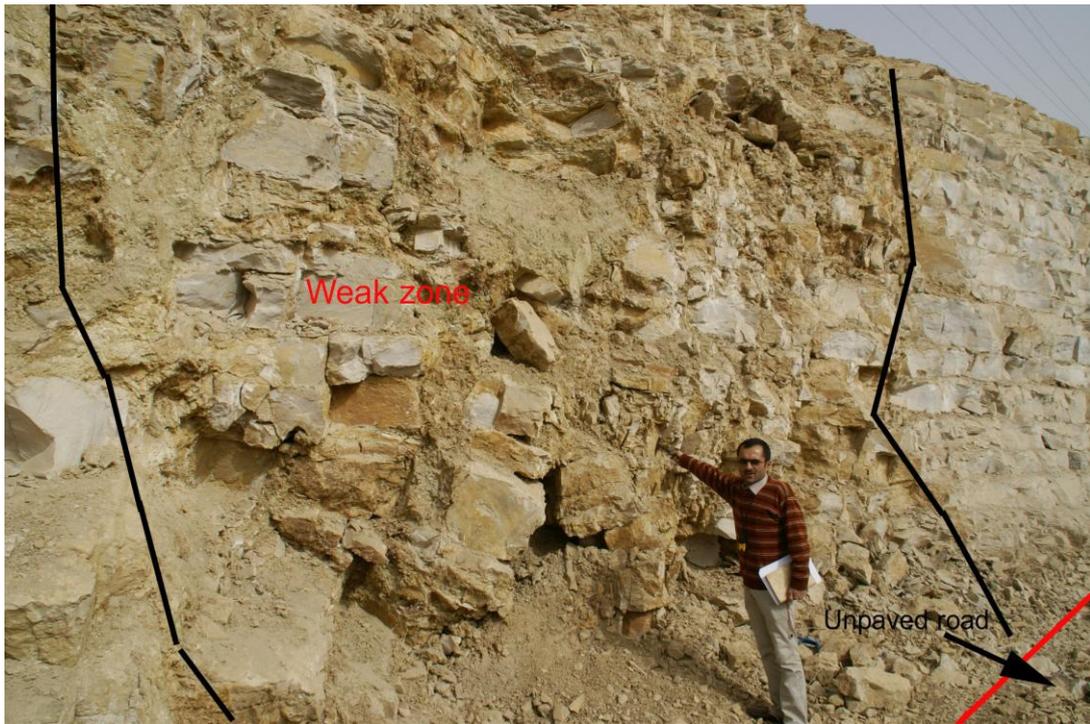
Plate 4-10a: Shows large weak zone at station No.6

The station is located on the SW limb of Kosrat anticline, along the main road between Dokan and Khalakan at latitude $35^{\circ} 56' 45''$ N and longitude $44^{\circ} 57' 08''$ E (Fig.4-11). It lies within Kometan Formation, The station is formed by man-made excavation. The slope at this station is a vertical slope exposing inclined rock layer (plate 4-9a), it is about 6m high and 40m long parallel to its strike. It is covered by soil in the upper part, its attitude is $210/90^{\circ}$ to overhanging Figure(4-17), and it contains many weak zones which are completely fractured, plate (4-10a).

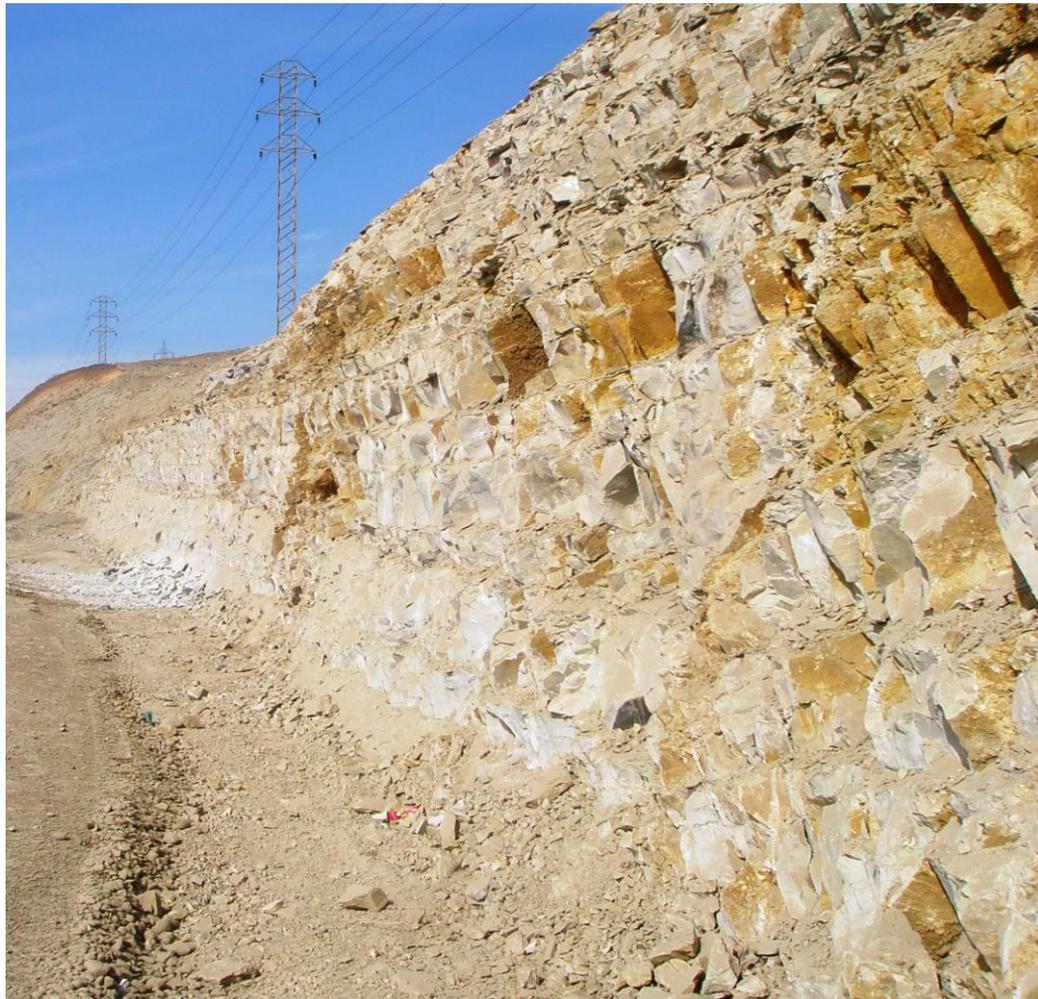
Plate 4-10b: Shows the probability of toppling at station No.6

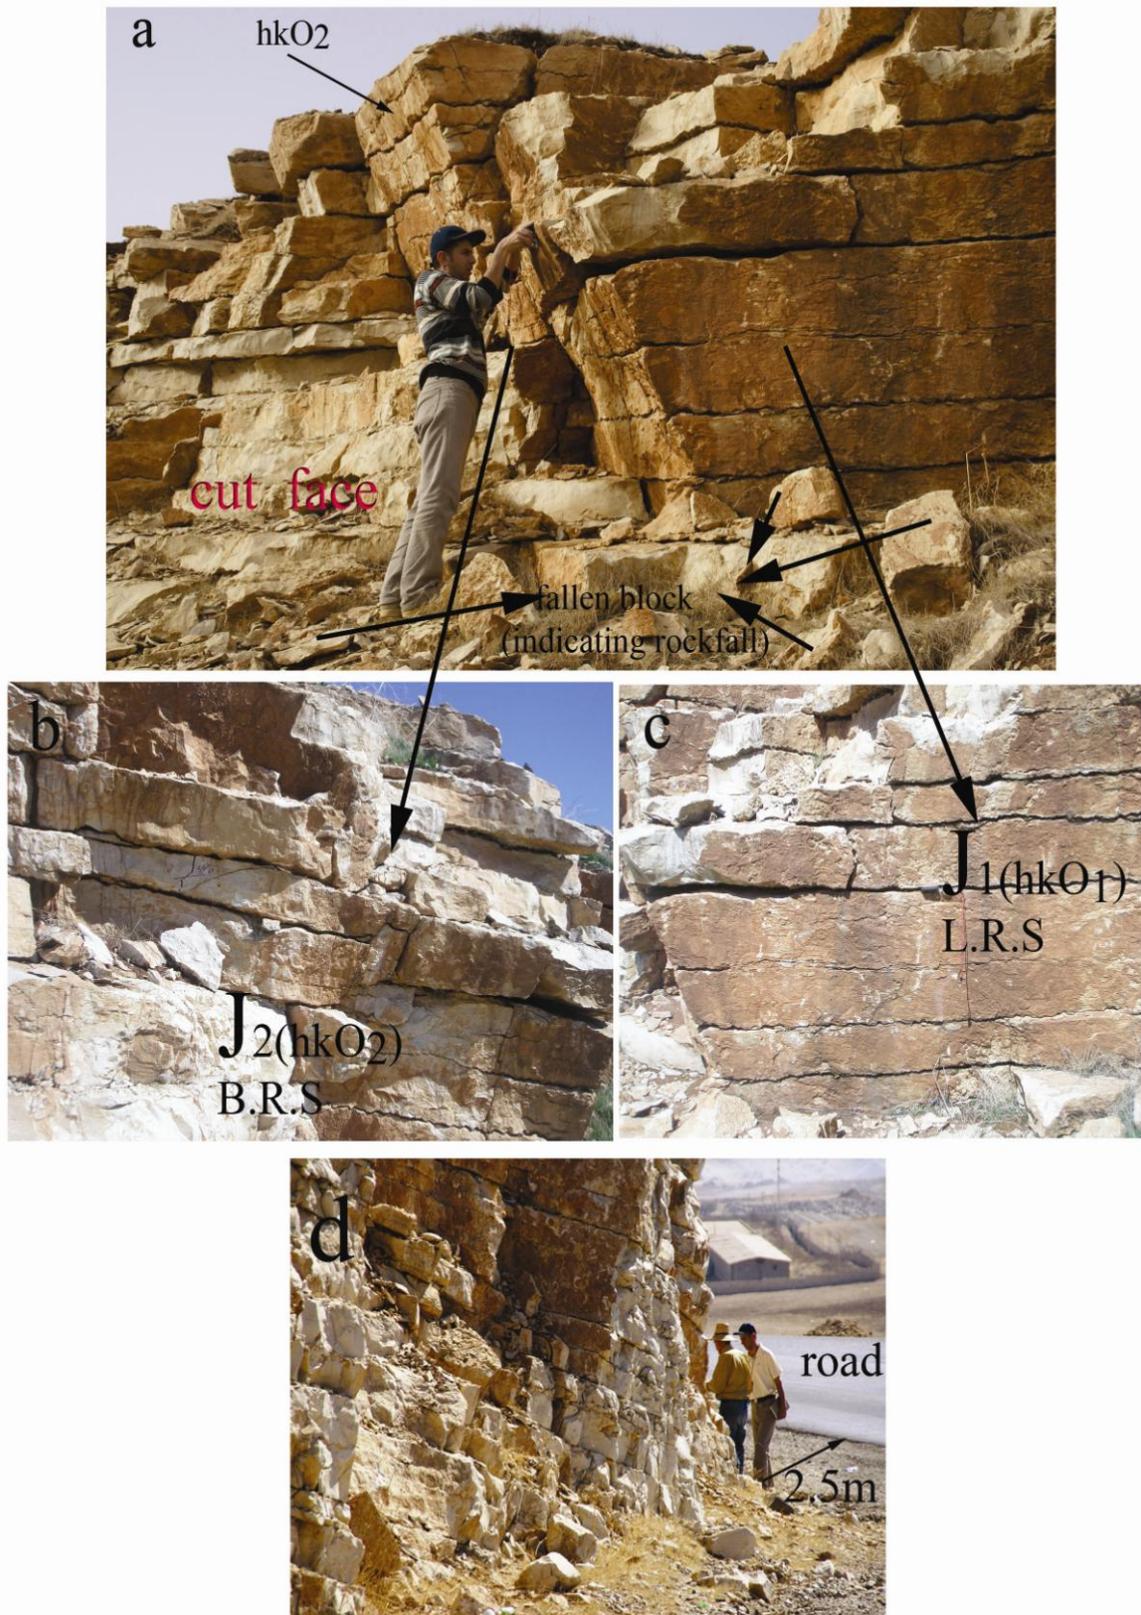
Plate (4-14):a) Lateral view of the slope at station No.9 on the main road shows cut face and fallen rocks b) Shows joints of $J_2(hkO_2)$ B.R.S) (c)Shows joints of $J_1(L.R.S)$ (d) Lateral view of the slope at station No.9 shows the main road from Dokan to Khalakan

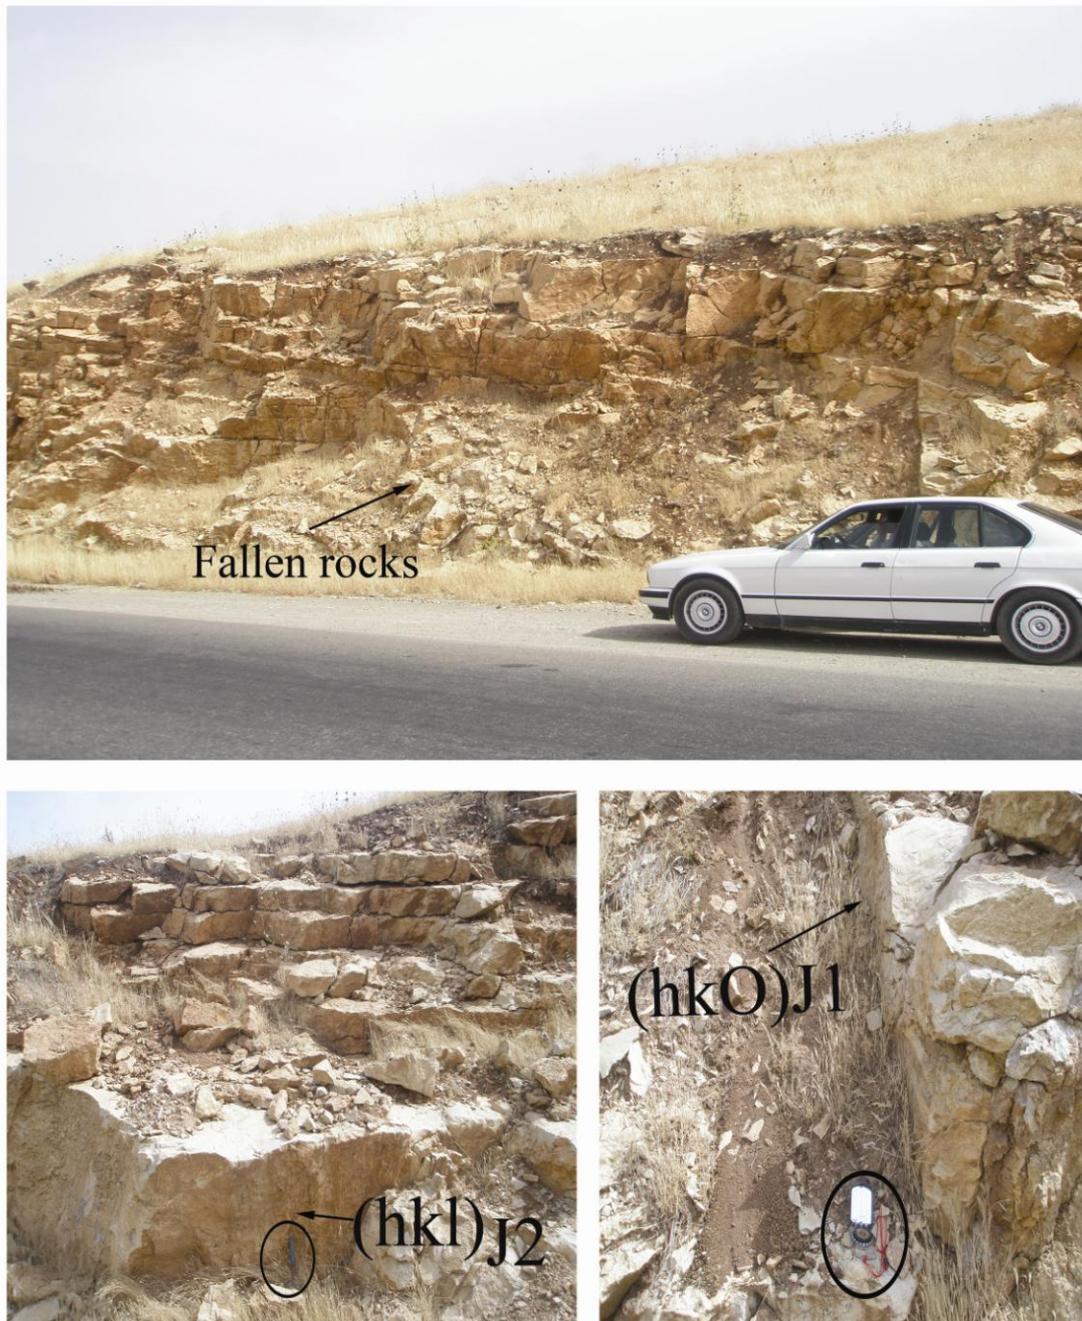
Plate 4-18: a) Frontal view of the slope at the station No.13 along the Dokan to Khalakan road. B and C) Show joint sets (hkl and hkO) at station No.13
